**TBPOC CONFERENCE CALL
April 22, 2013, 4:00pm – 5:00pm**

RE: Agenda No. - 3a
Program Issues
Item- Status Update on Anchor Rods

Briefing on E2 Anchor Bolts – April 24, 2013

THE SAN FRANCISCO-OAKLAND
BAY BRIDGE
SEISMIC SAFETY PROJECT

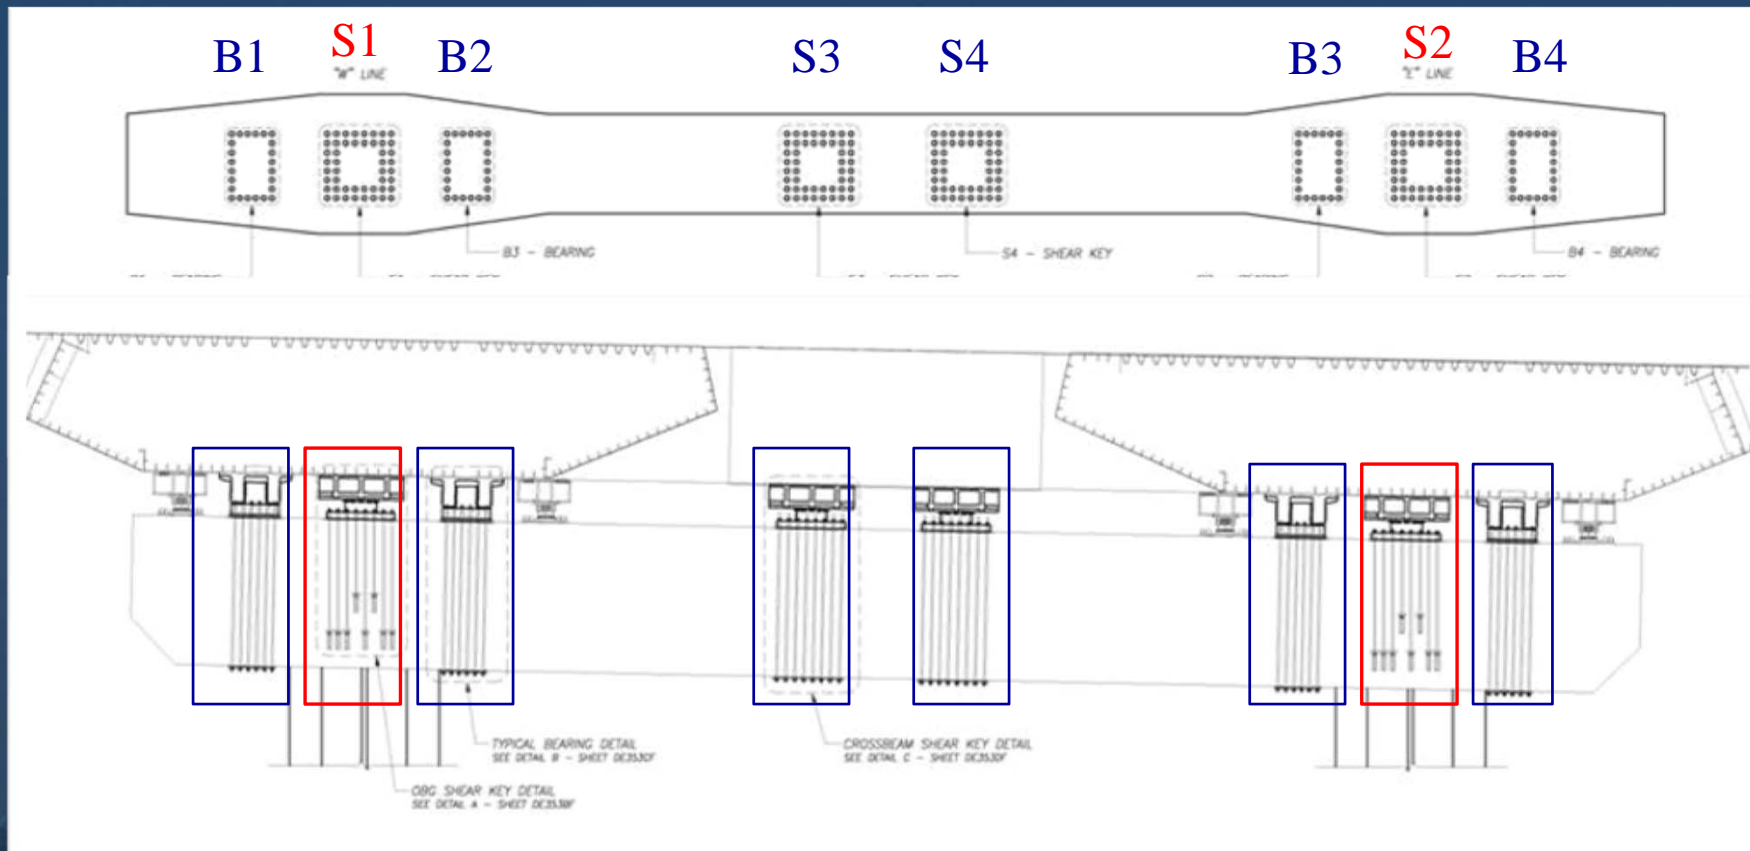
- Bearings and shear keys are secured to E2 by 3 inch diameter anchor bolts, ranging from 9 feet to 24 feet in length.
- 96 Bolts manufactured in 2008 are shown in red.
- 192 Bolts manufactured in 2010 are shown in blue.

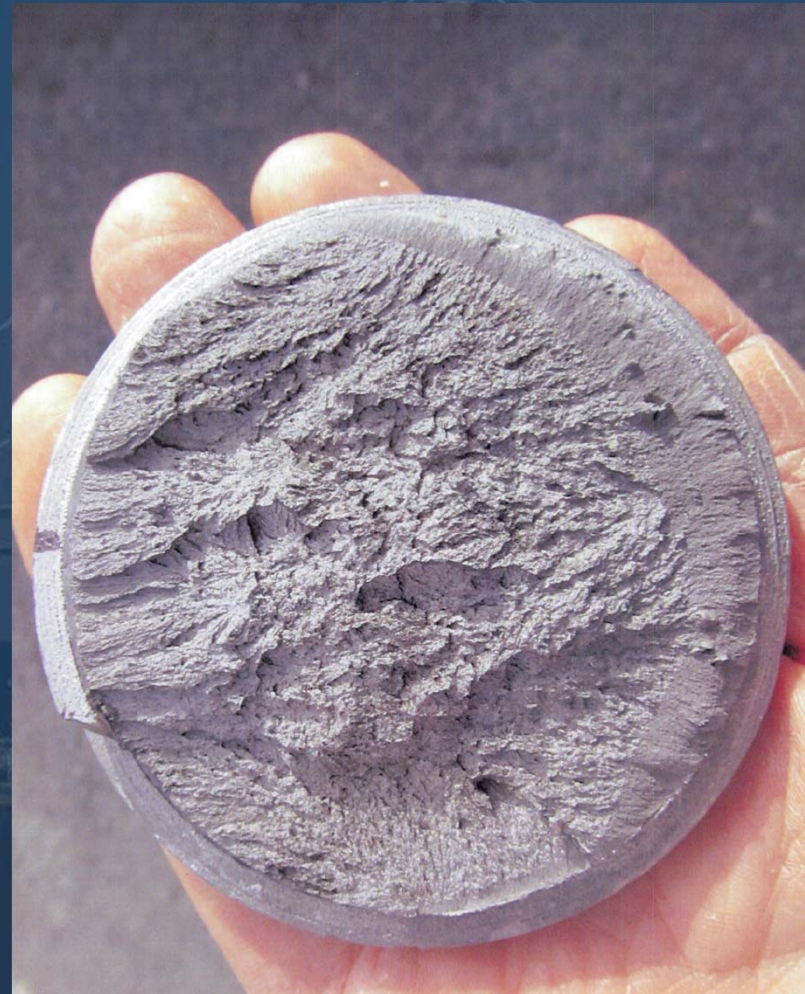
Failure of 2008 Bolts Due to Hydrogen Embrittlement

- Under detail investigation, 2008 bolt failures are due to hydrogen embrittlement.
- Excess hydrogen in the 2008 bolts caused the threaded areas of bolts to become brittle and fracture under high tension.

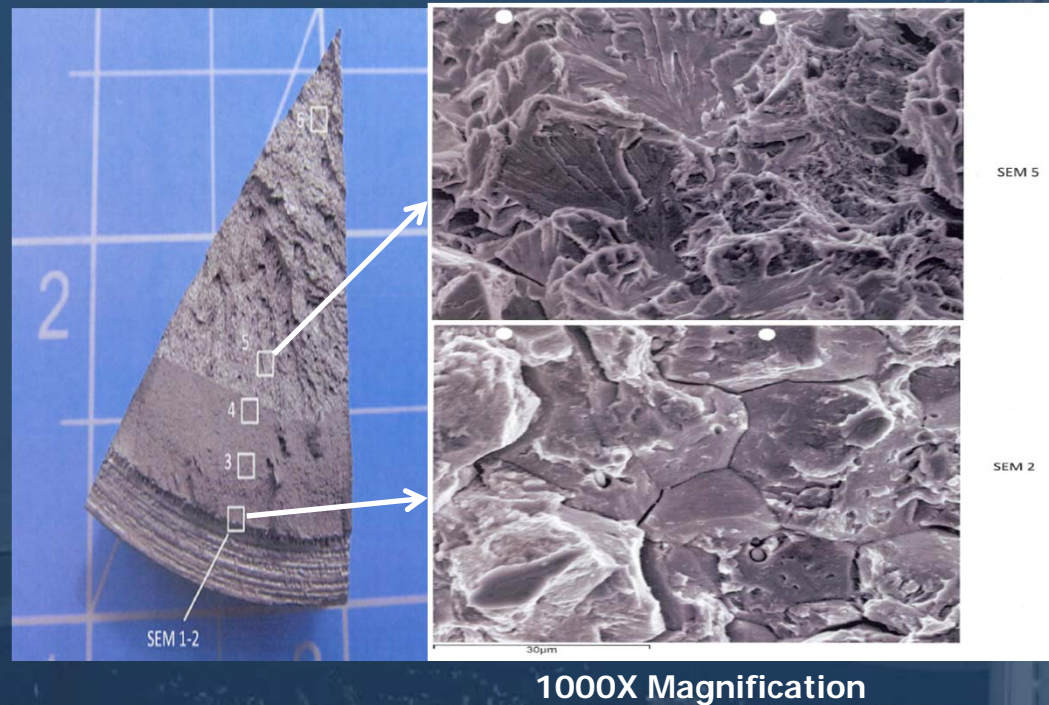
Hydrogen Embrittlement

- Sources of excess hydrogen can be introduced in the fabrication and/or external from the environment.
- Identified under electron microscope.

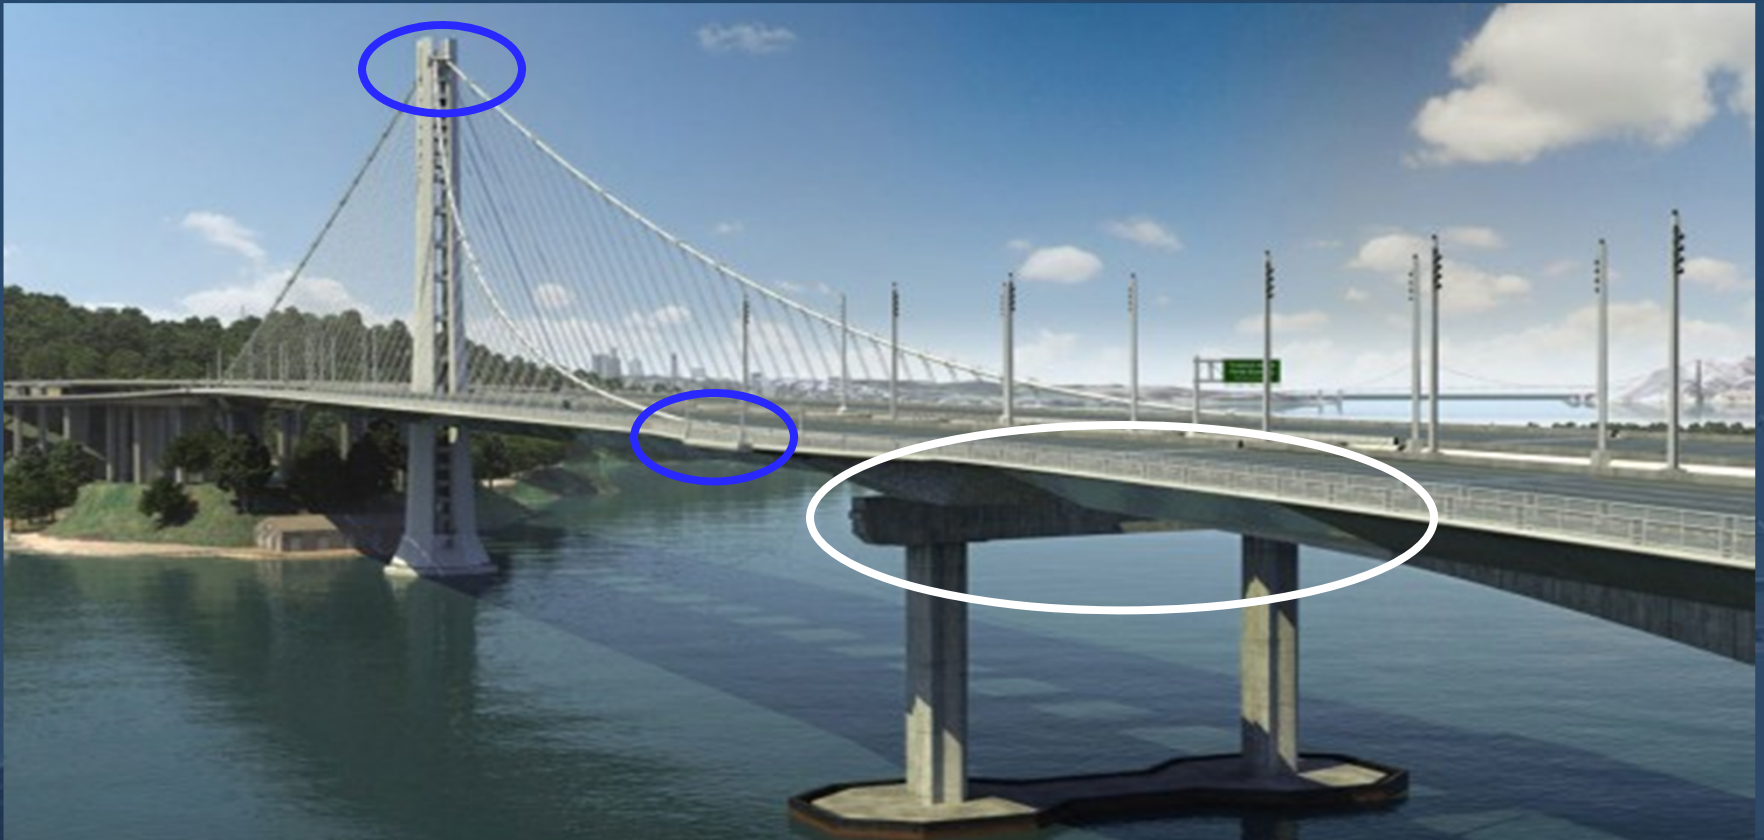
- Visual inspections of similar anchor bolts revealed no abnormalities.
- Some E2 Bearing assembly bolts are not accessible to inspection.
- Most anchor bolts at other locations are under lower tension levels.
- Desk Audit of QC/QA results will be completed by May 8.
